SIMULATED SOLAR HEAT TEST OF MUST WARD CONTAINERS

September 18, 1970

J. W. Grimes, W. J. Mulroy and T. W. Reichard
Building Research Division
Institute for Applied Technology

U. S. Army Natick Laboratories
Natick, Massachusetts

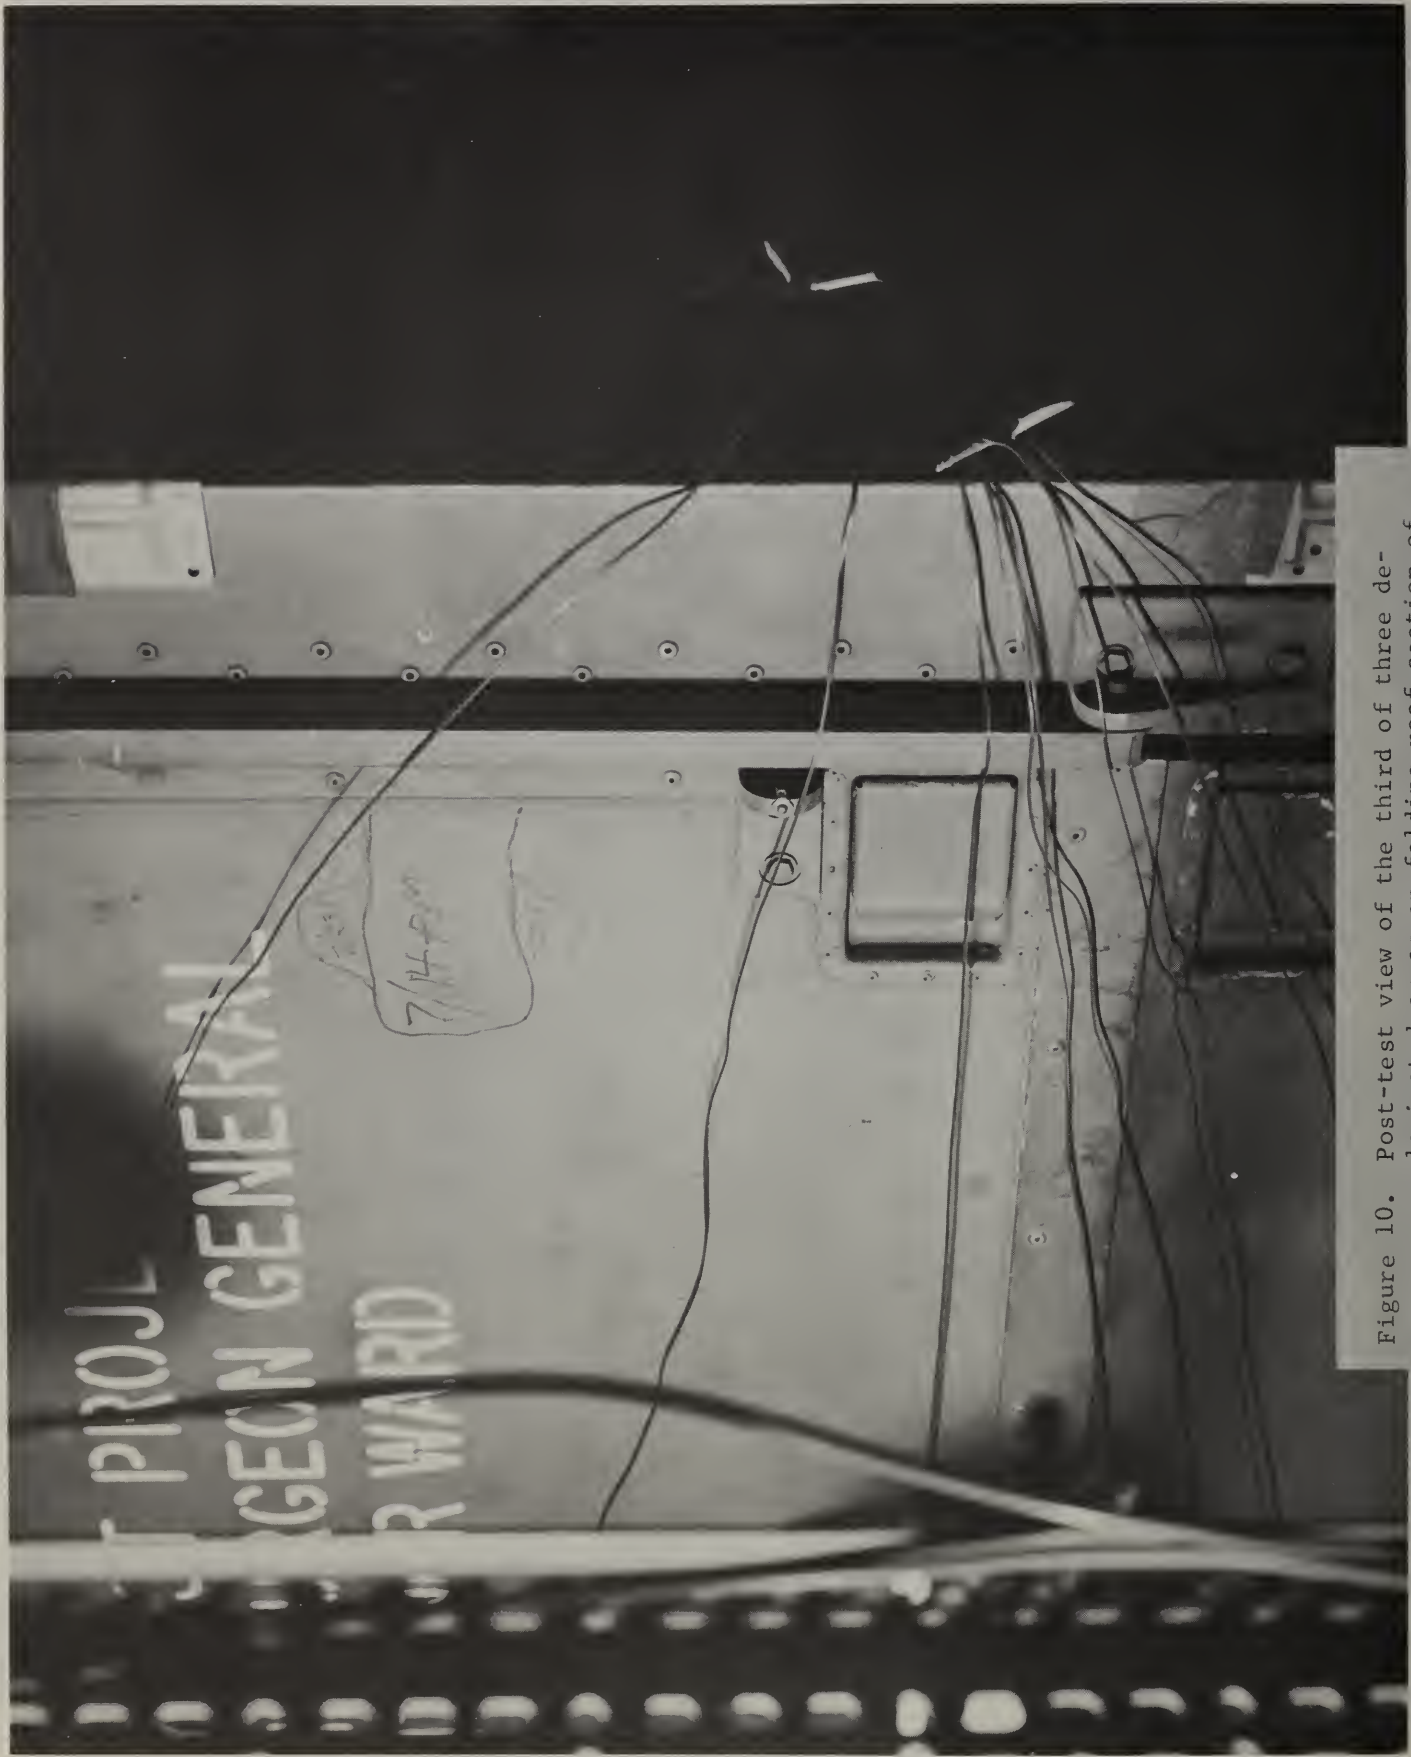
Figure 10. Post-test view of the third of three de-laminated areas on folding roof section of Ward A. (See figure 4).

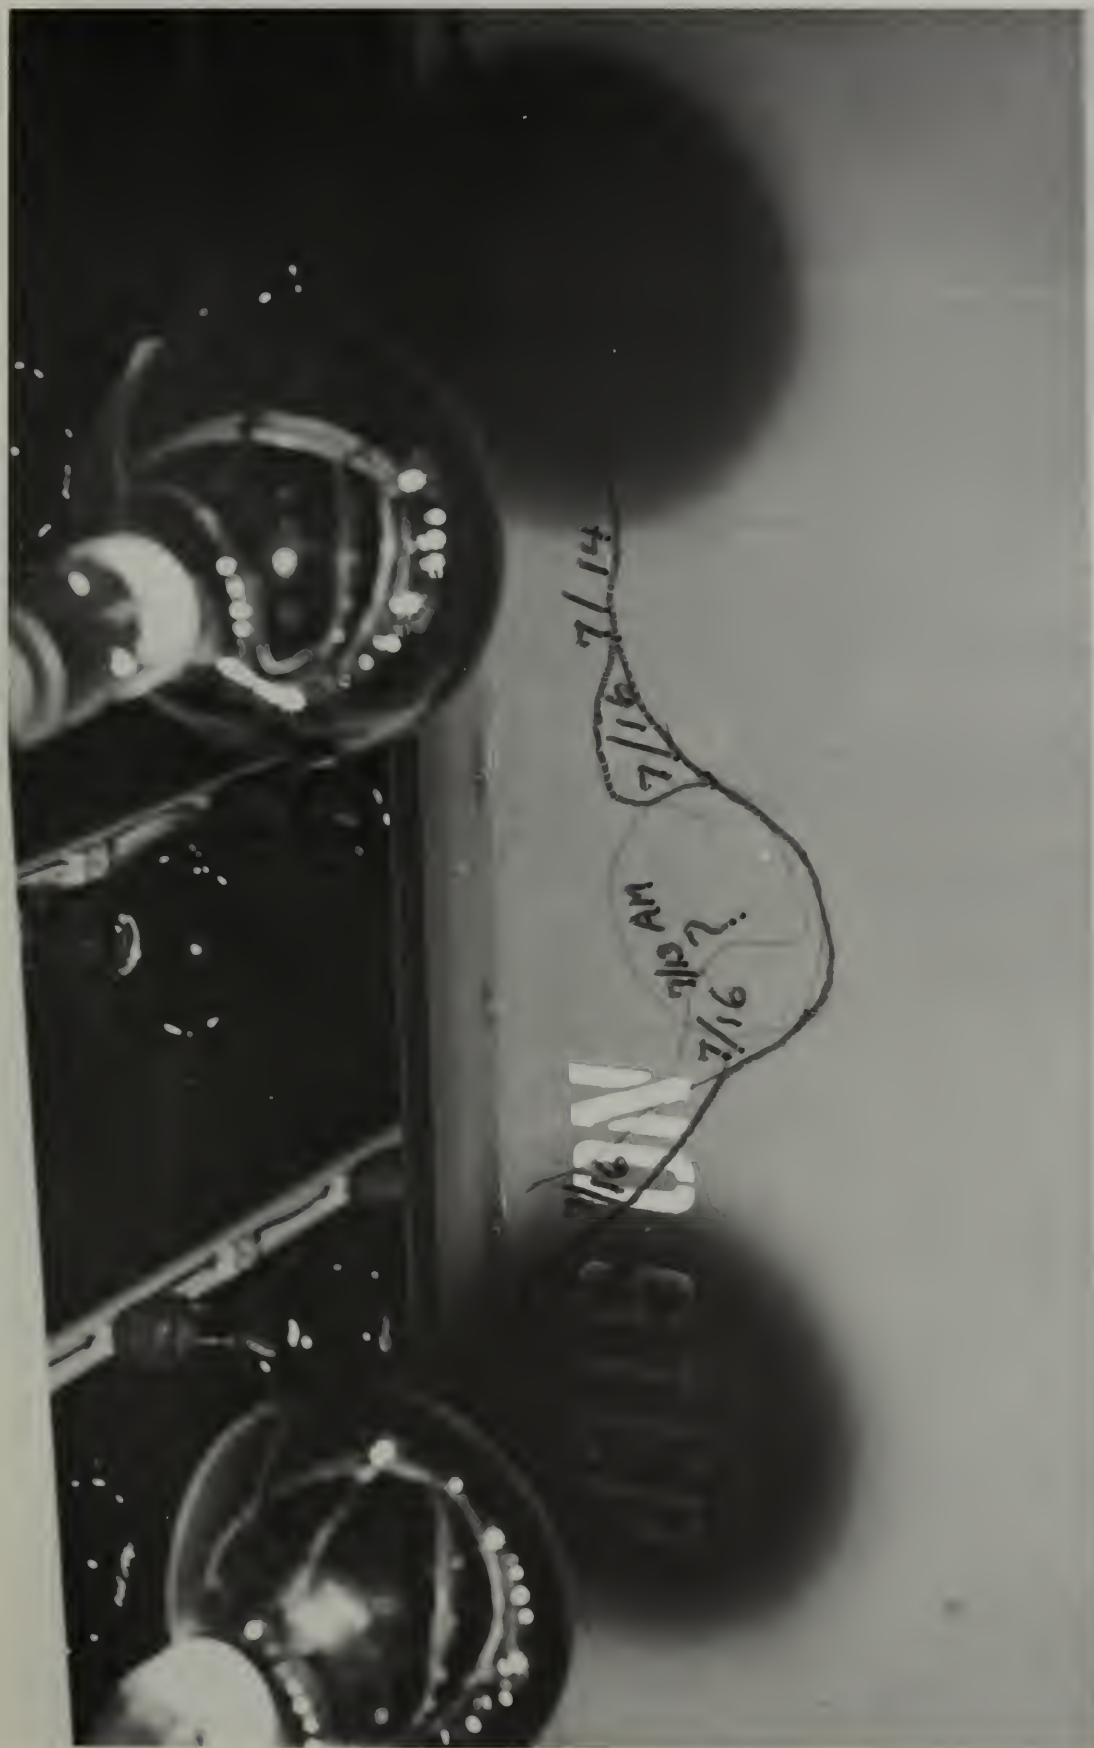
Figure 11. Post-test view of one of two delaminated areas on the folding roof section of Ward B. See figure 5 for location.

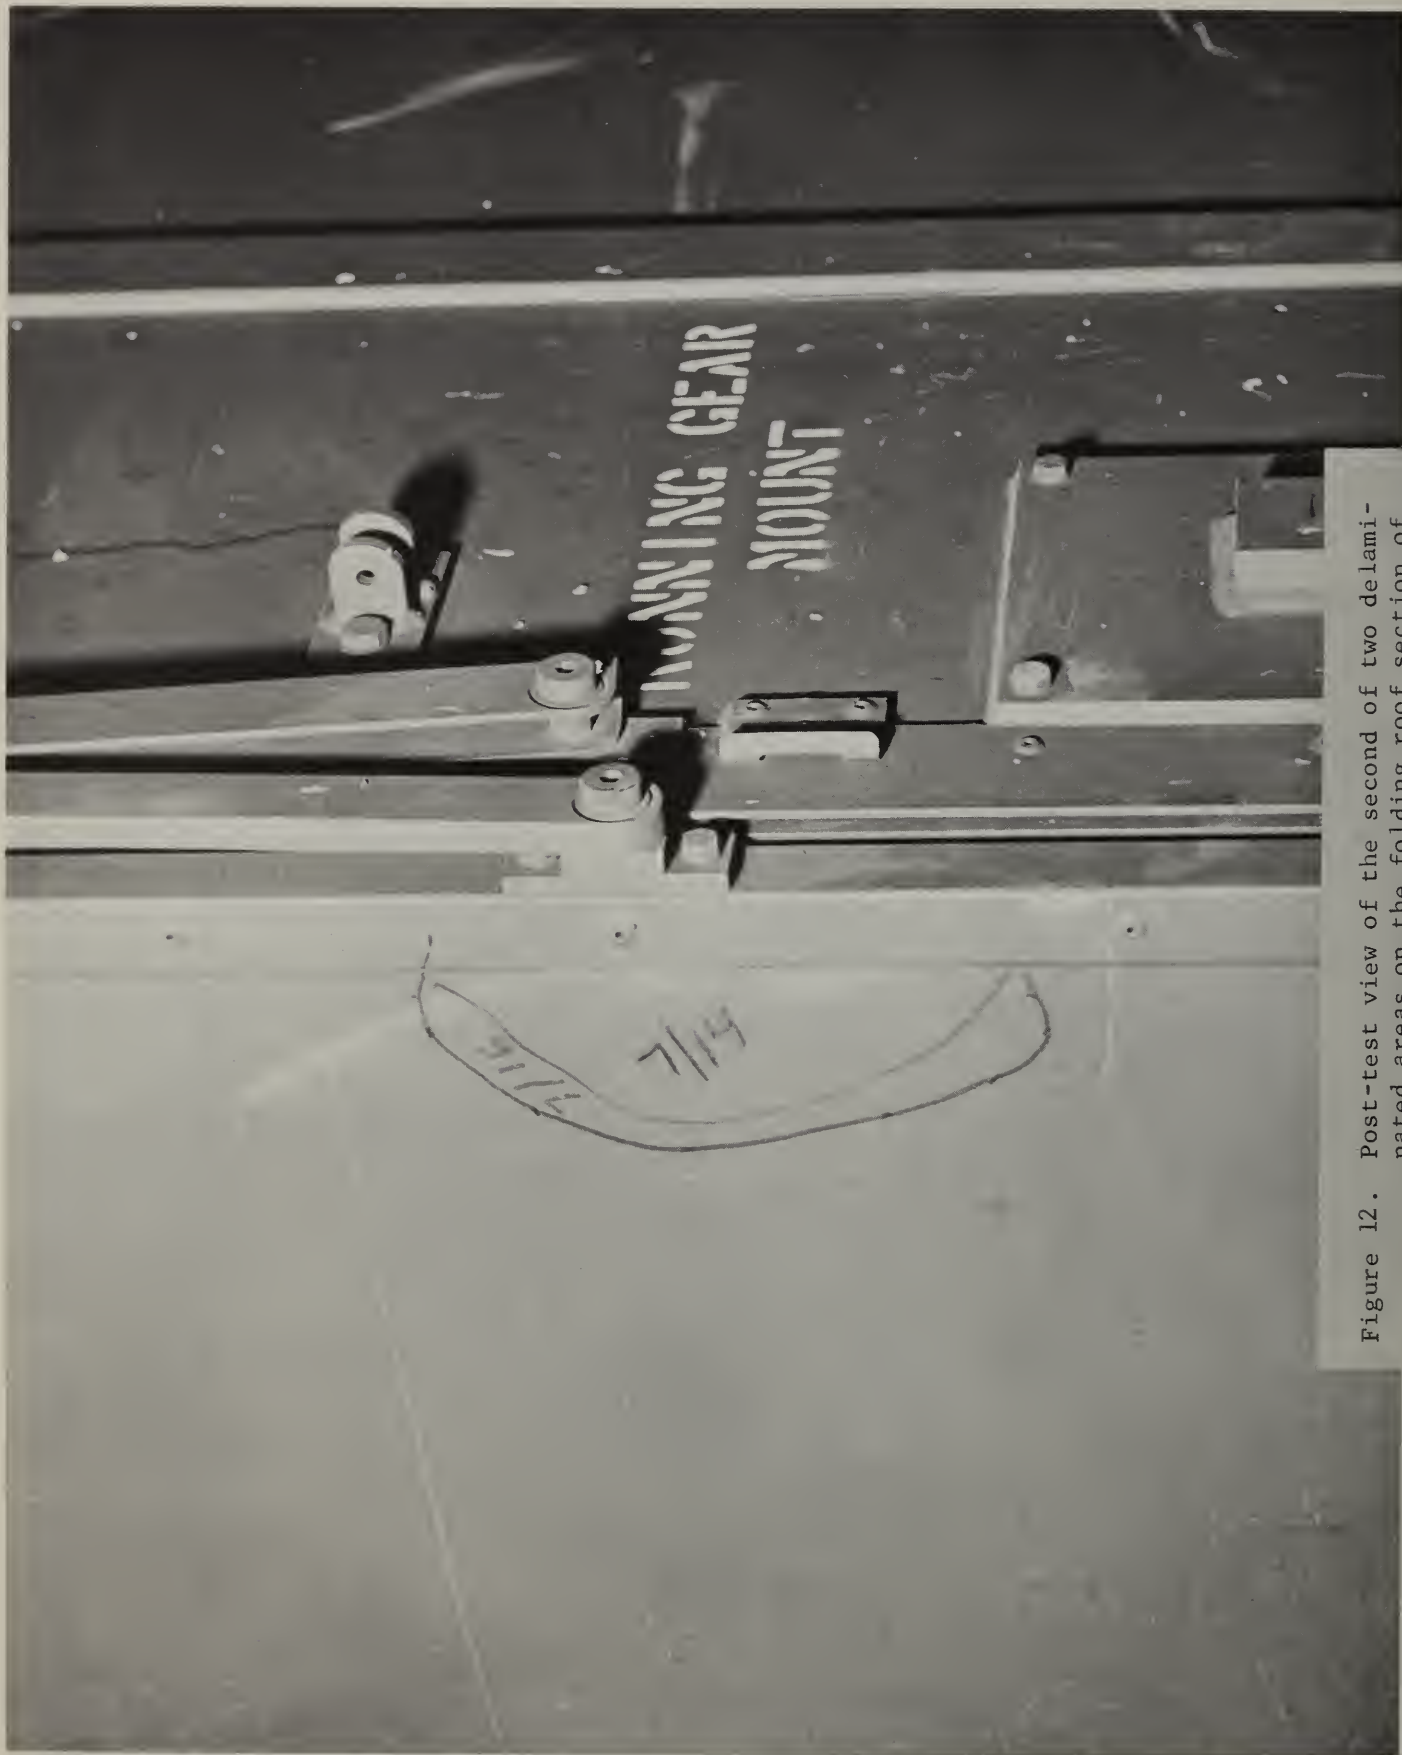
Figure 12. Post-test view of the second of two delaminated areas on the folding roof section of Ward B. See figure 5 for location.

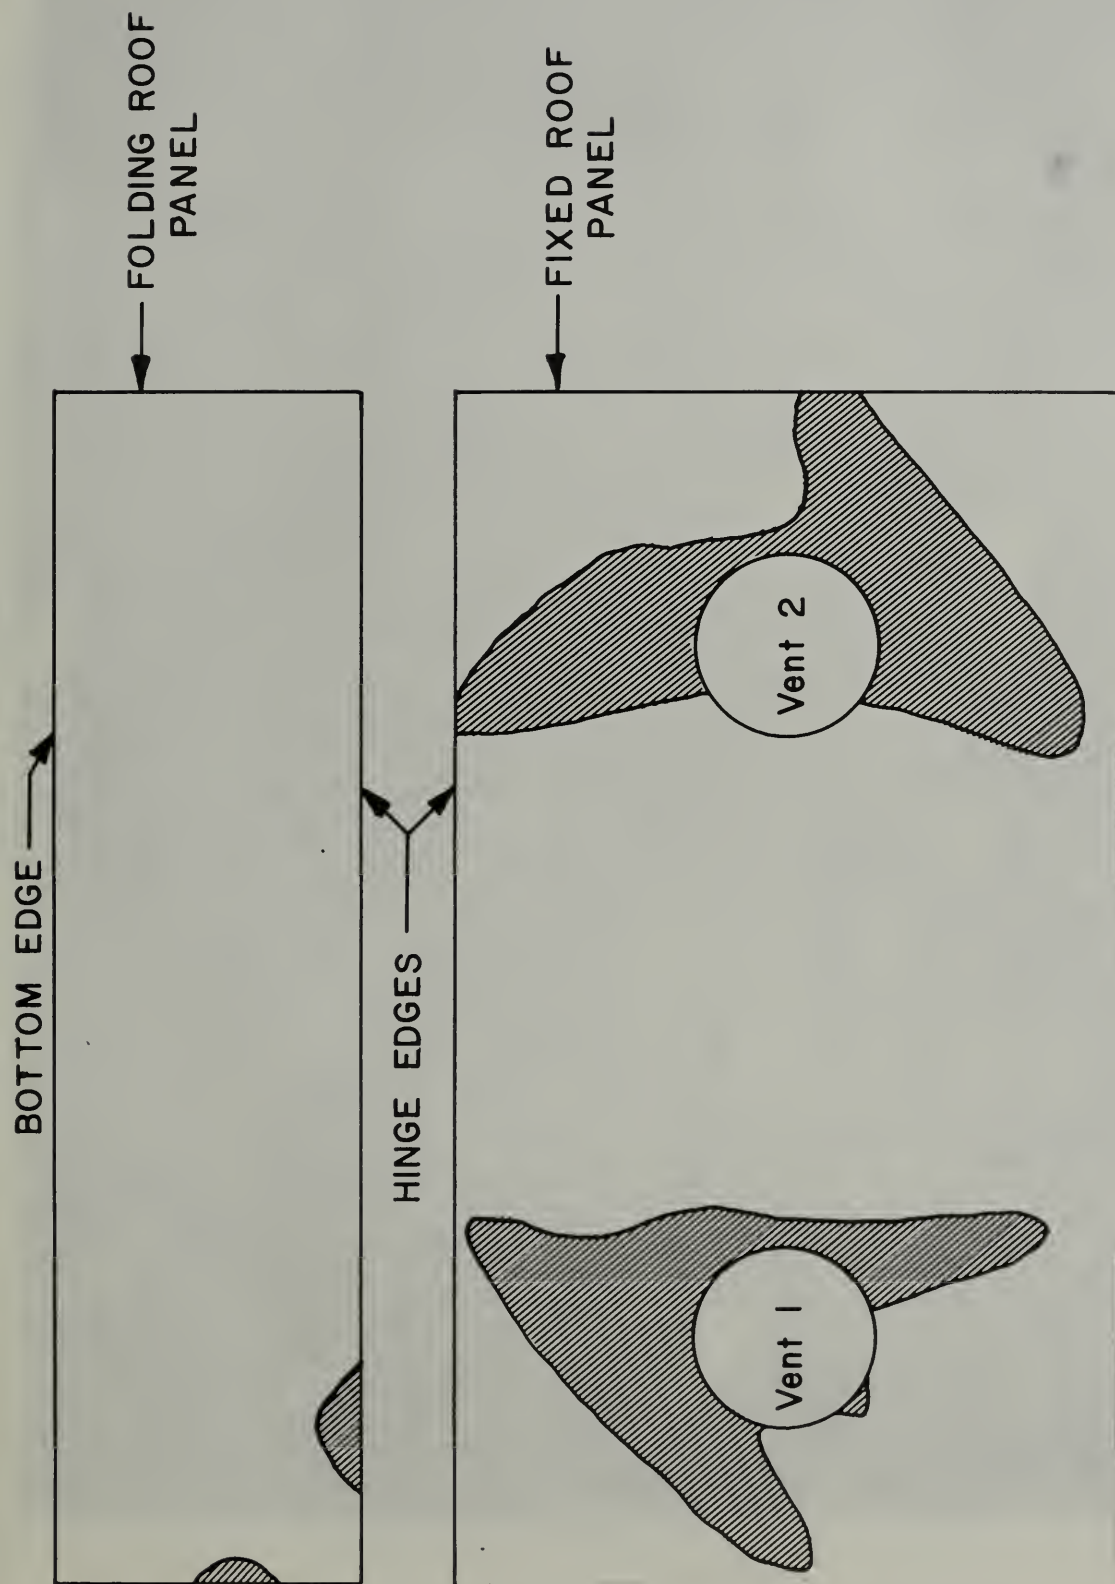
3. No delamination was observed on the fixed roof of the prototype ward (Ward A) whereas extensive delamination (20%) occurred on the fixed roof of the production sample (Ward B)
4. Delamination of the fixed roof of the production sample, Ward B, tended to start at the roof vents and spread progressively towards the roof edges with the daily temperature cycles. This differs from the pattern of delamination indicated on the ward container of figure 1.

Figure 13. Drawing of delaminated areas of Ward B. Cross-hatching indicates delaminated areas.

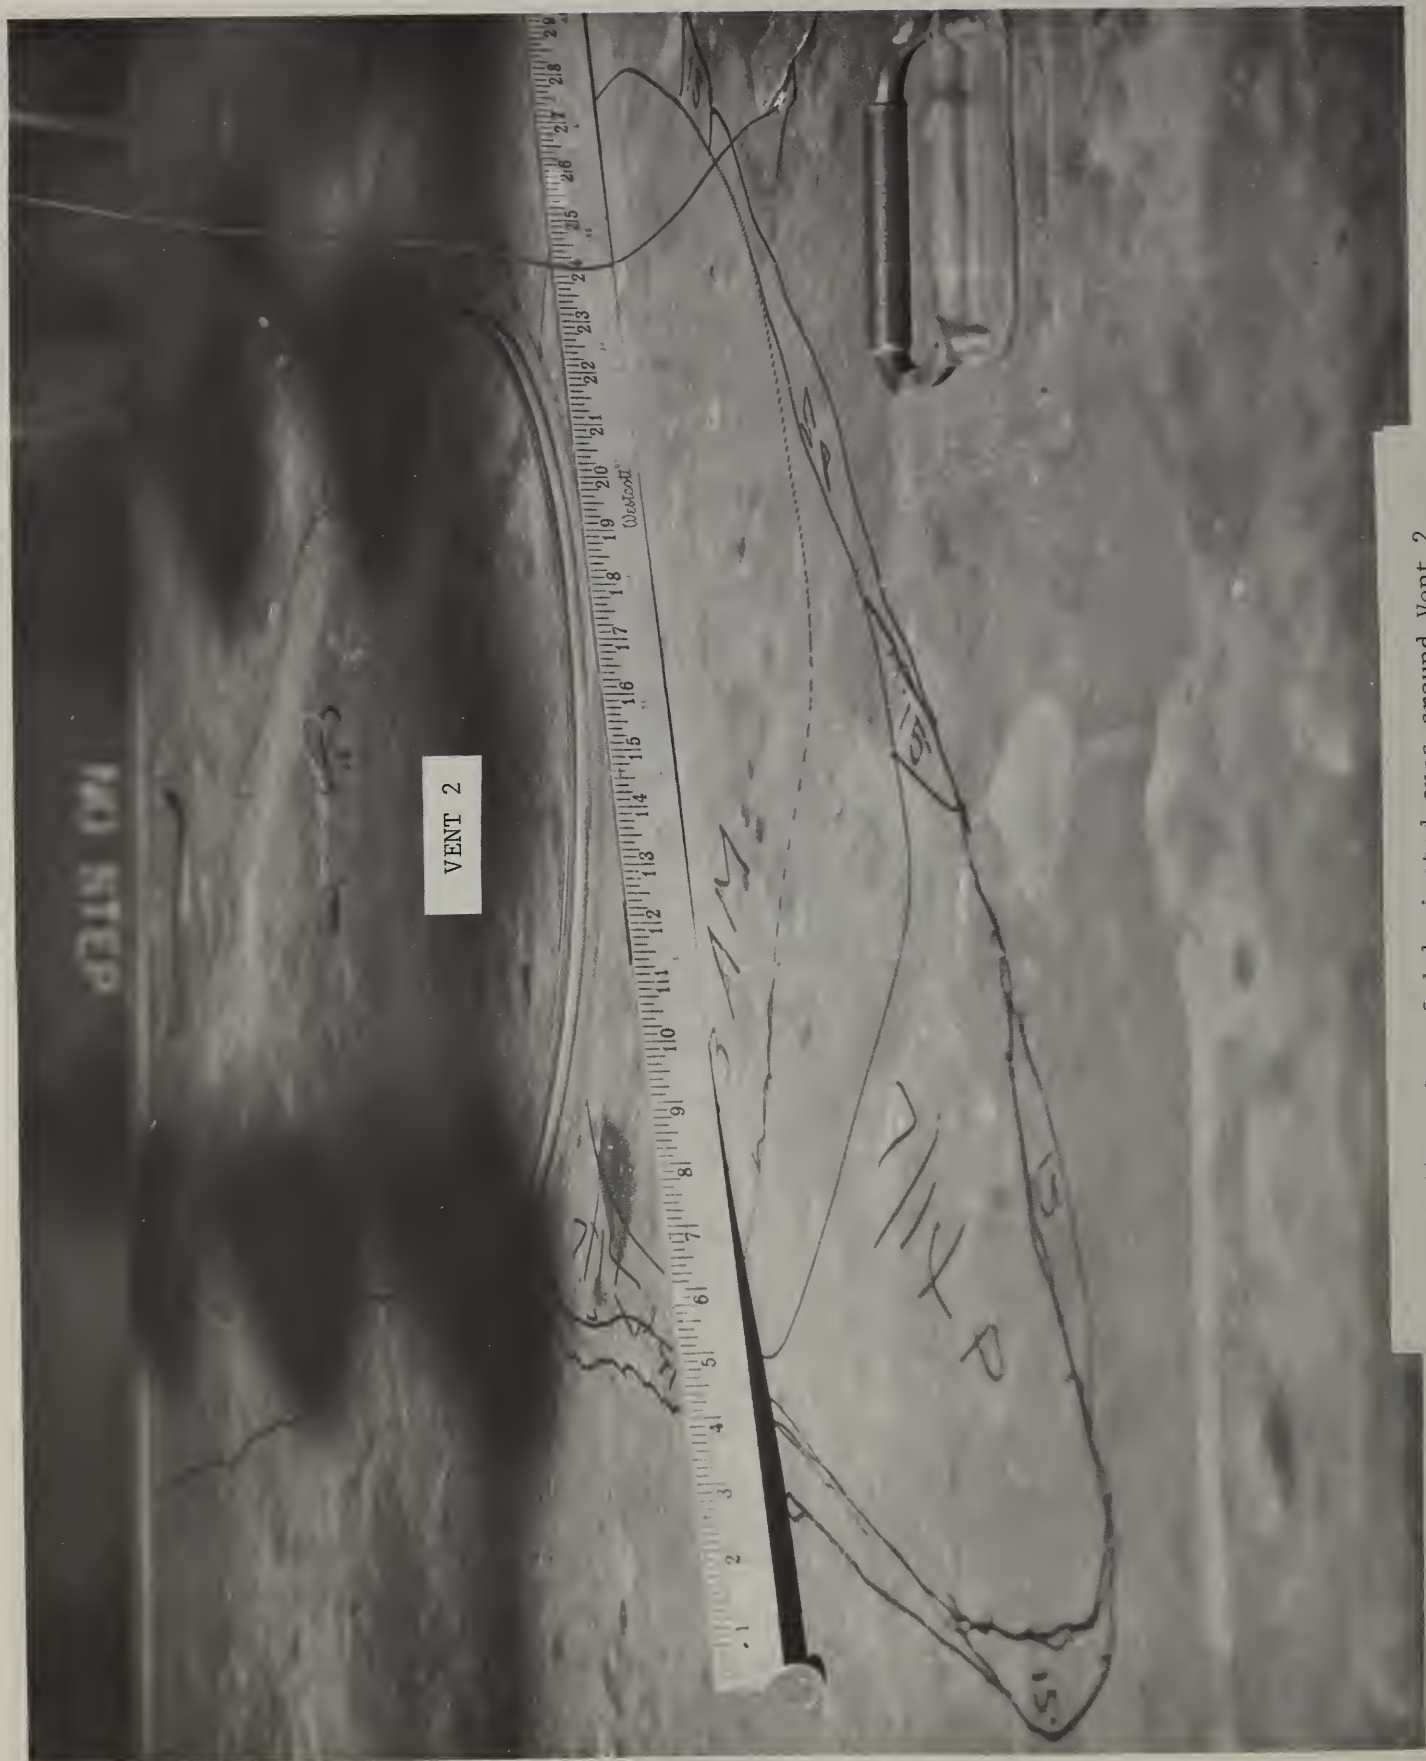
It was observed that the skins of the delaminated areas would rise during heating and return during cooling. See figure 14.

Figure 14. View of delaminated area around Vent 2, Ward B. See figure 13 for location.

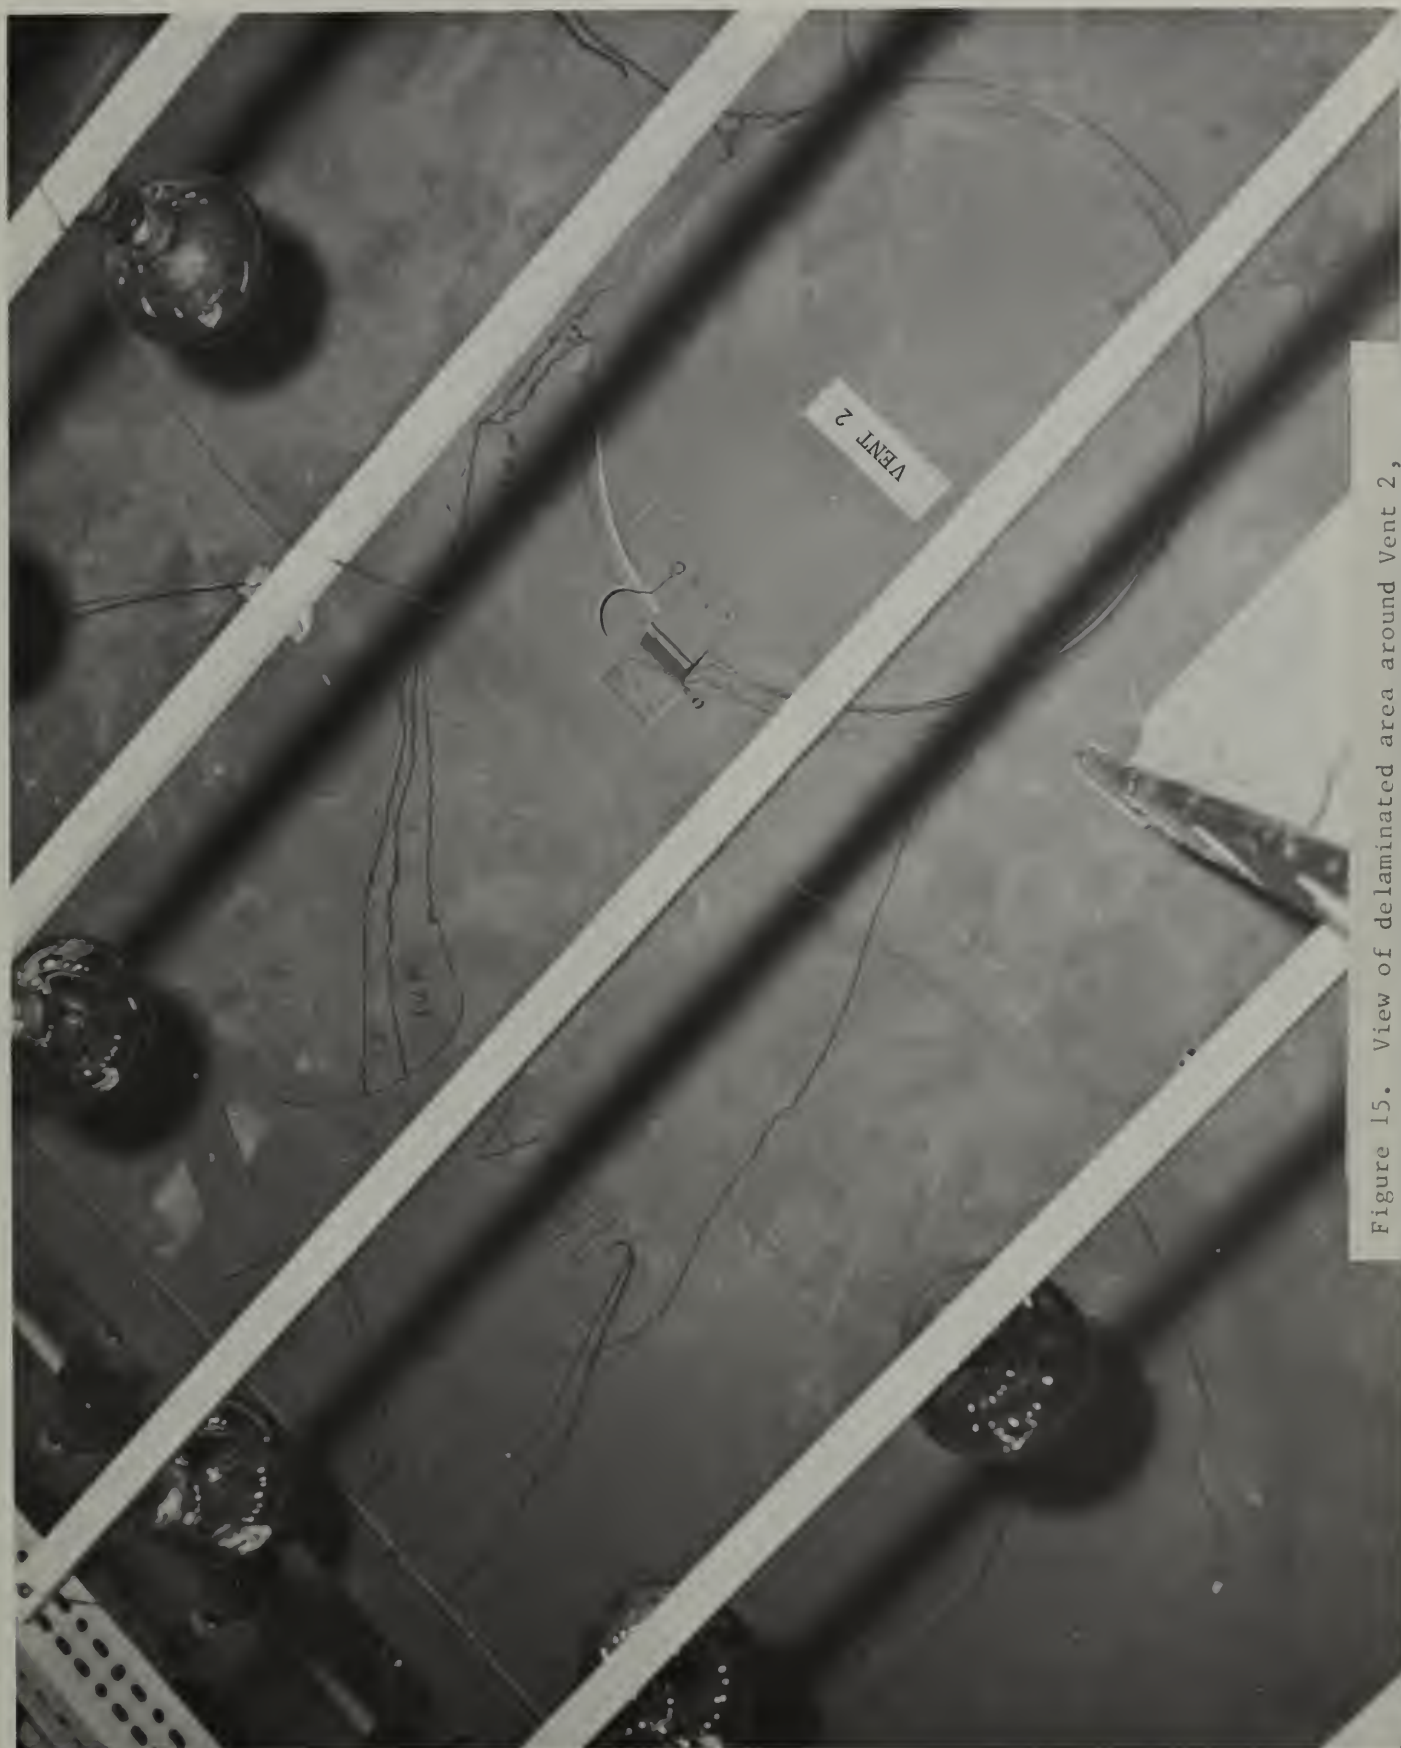
After the tapping test was completed the heat lamp bulbs were installed, their operating voltage determined, and sufficient cooling installed in the wards to maintain their interior temperature near the desired value. During the checkout period for this apparatus the average fixed roof ward skin temperature was raised to approximately 165 °F for short periods of time on several days (1 hr on the July 2nd, 2 hrs on the 6th, 5 hrs on the 7th, 3 hrs on the 8th, 1 hr on the 9th, and 5 hrs on the 10th). During the remainder of the checkout period the ward skins were exposed to a laboratory ambient temperature which ranged from 70 °F to 100 °F. Another tapping test was then performed on 7/13. Large areas on the roof of Ward B were found to be delaminated and were marked, see figure 15.

Figure 15. View of delaminated area around Vent 2, Ward B. See figure 13 for location.

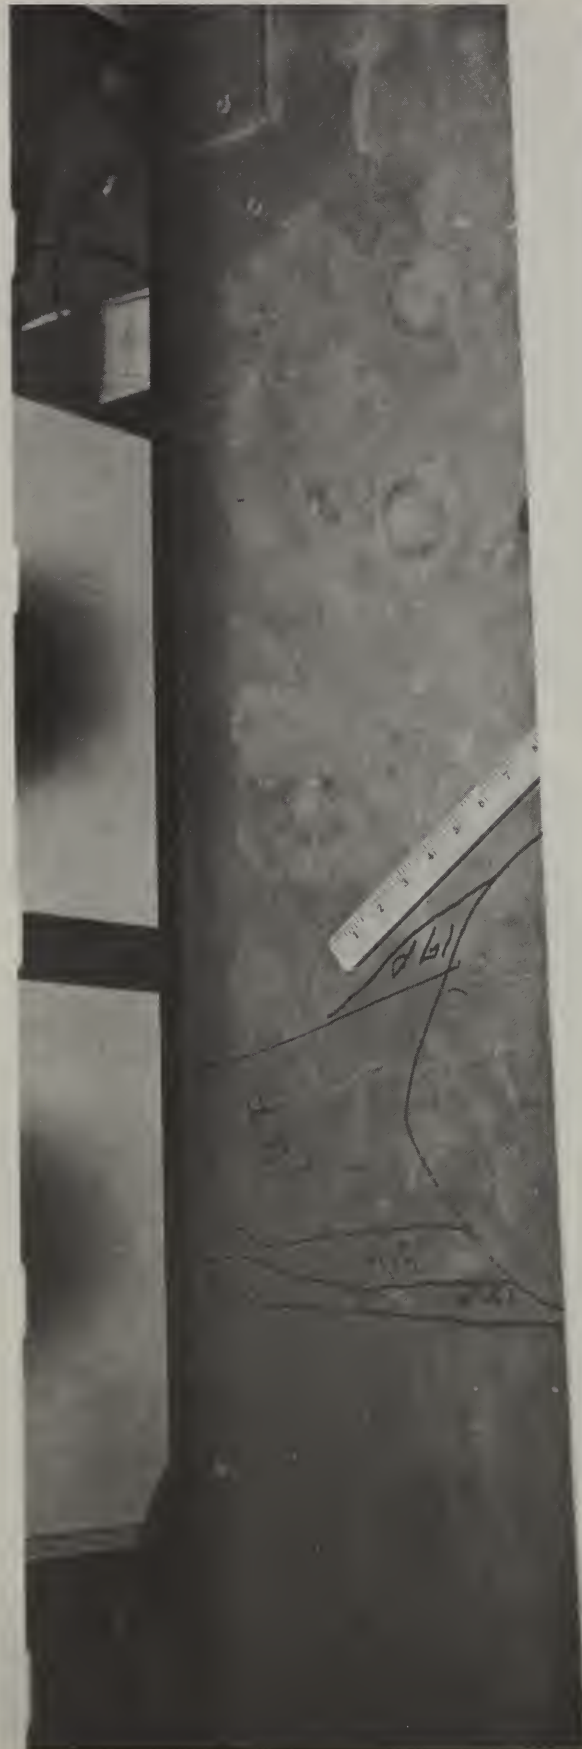
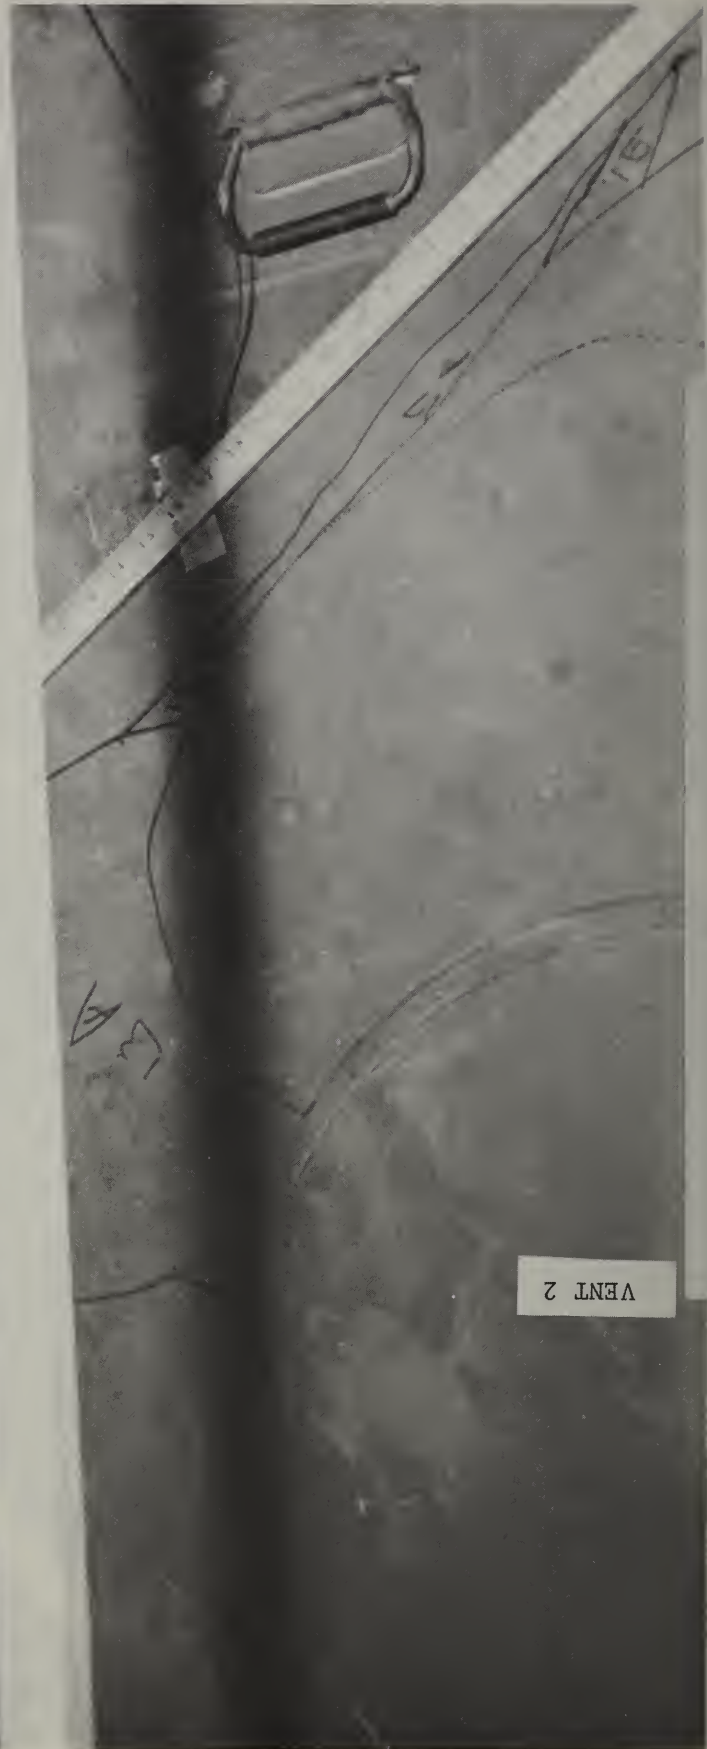
VENT 2

Figure 16. View of delaminated area around Vent 2, Ward B. See figure 13 for location.

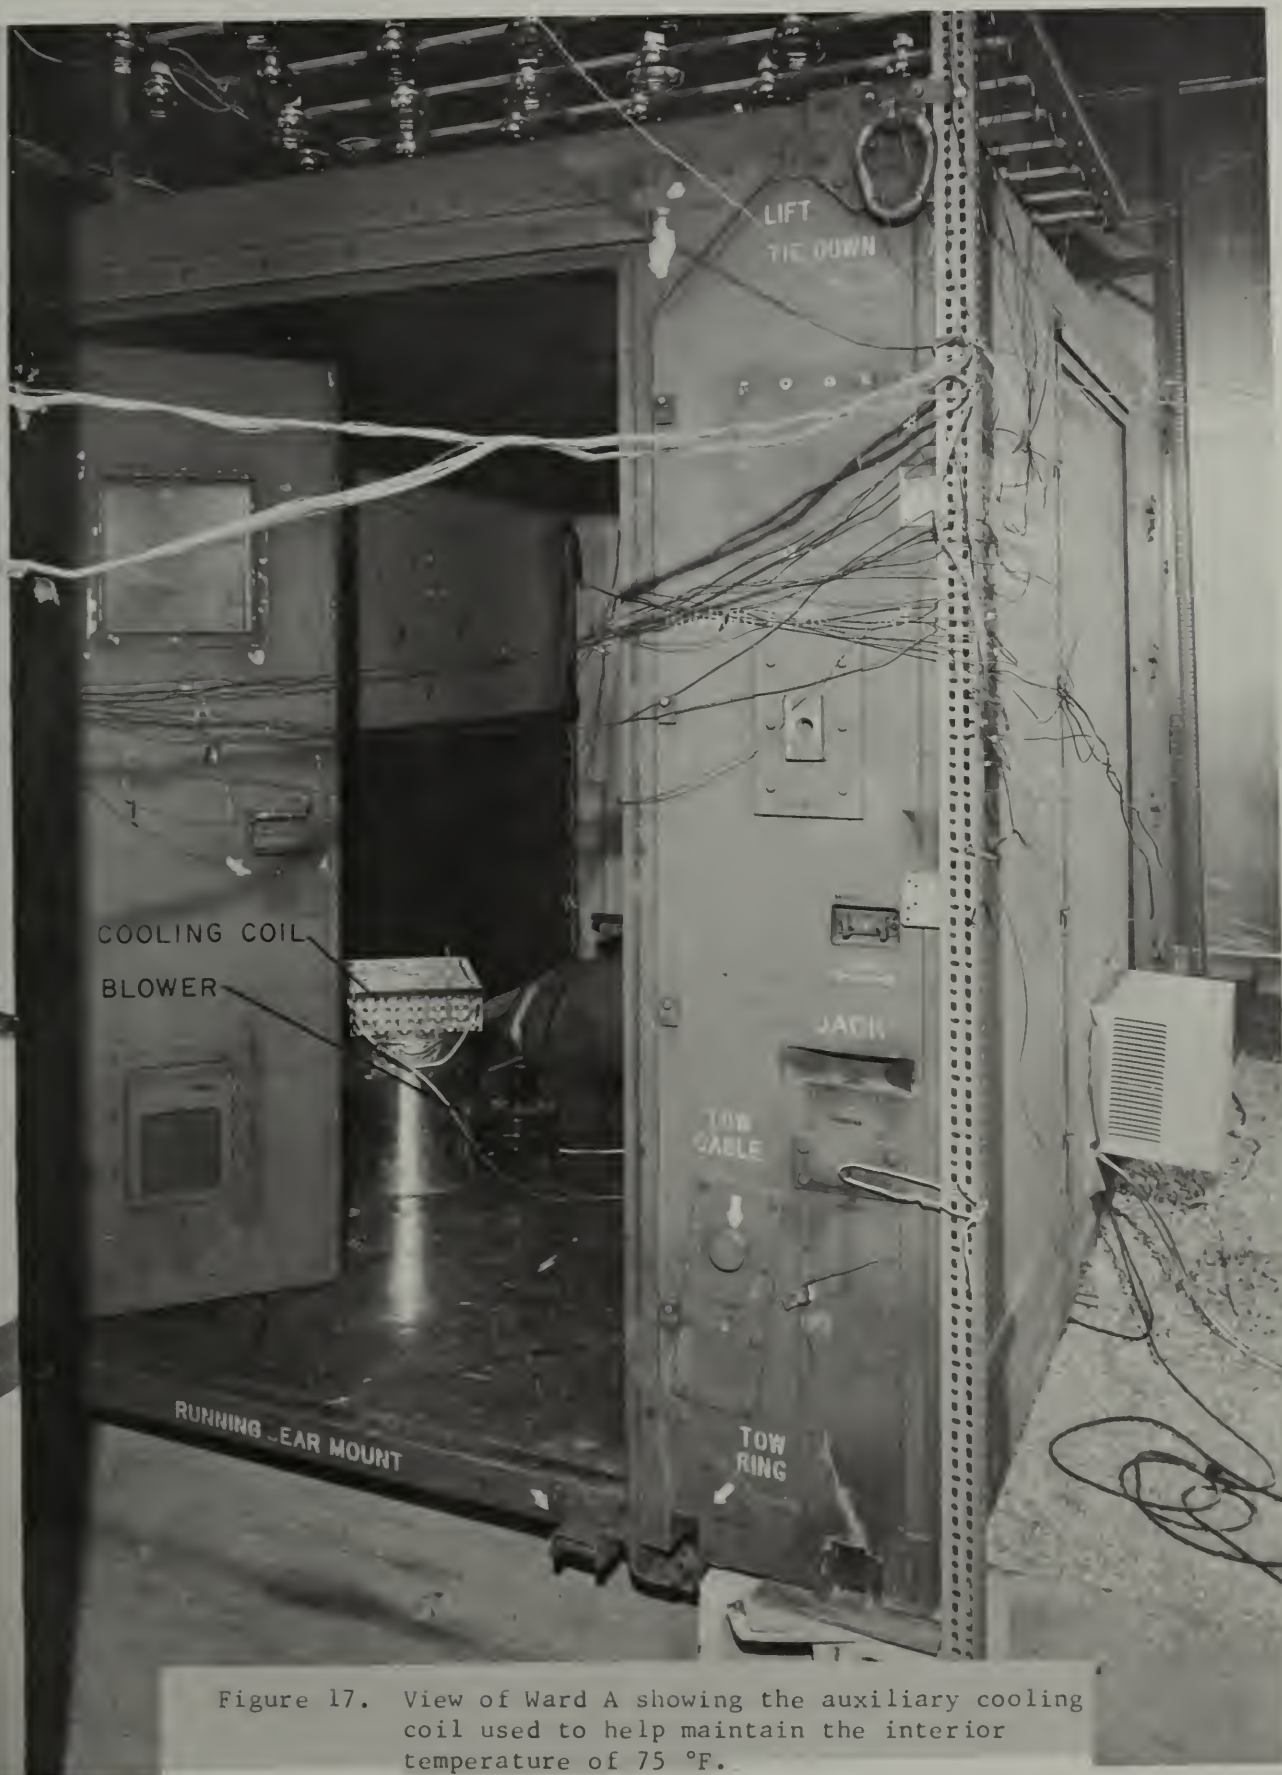
The interior temperature of each container was maintained at about 75 °F using a package air conditioning unit (5000 Btu/hr) plus non-thermostated cooling coils (see figure 17) for use during the high ambient temperature periods of the daily cycle. These coils were cooled with 42 °F chilled water.

Figure 17. View of Ward A showing the auxiliary cooling coil used to help maintain the interior temperature of 75 °F.

It was also observed during the checkout period that the single cooling coil in Ward B (same size as in Ward A) did not provide enough cooling effect and an additional coil of the same size was added to Ward B.
